# Water Compliance Inspection Report

**National Pollutant Discharge Elimination System  
(NPDES)  
Compliance Evaluation Inspection Report**

**Kinross DeLamar Mine  
DeLamar, Idaho**

**Inspection date: September 8, 2016  
Report completion date: February 6, 2017**

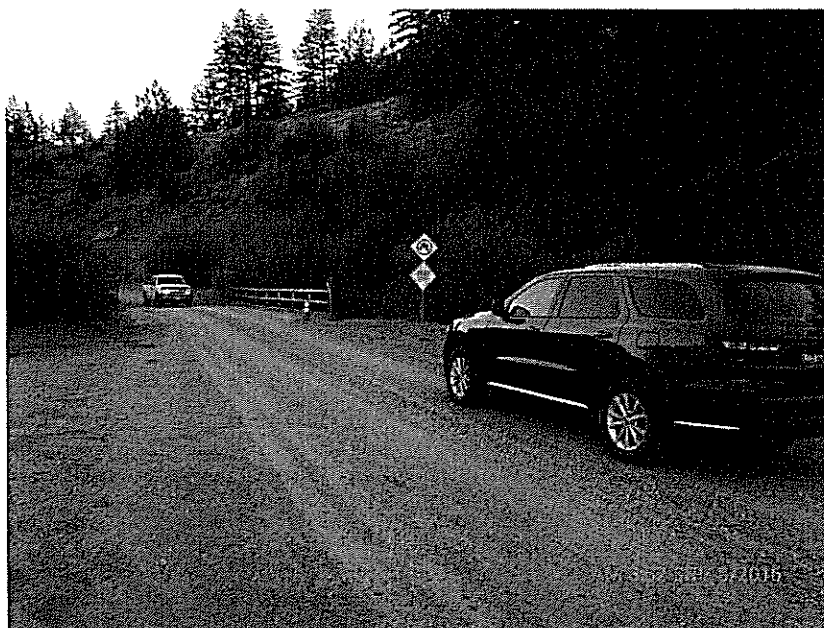
Photo No. 7 (P1020372)

Facing east – there is a fork in the road just before the access road to the DeLamar mine; the left fork parallels Jordan Creek as it continues on to historic Silver City. The right fork (pictured here) crosses the creek and leads directly to the mine.

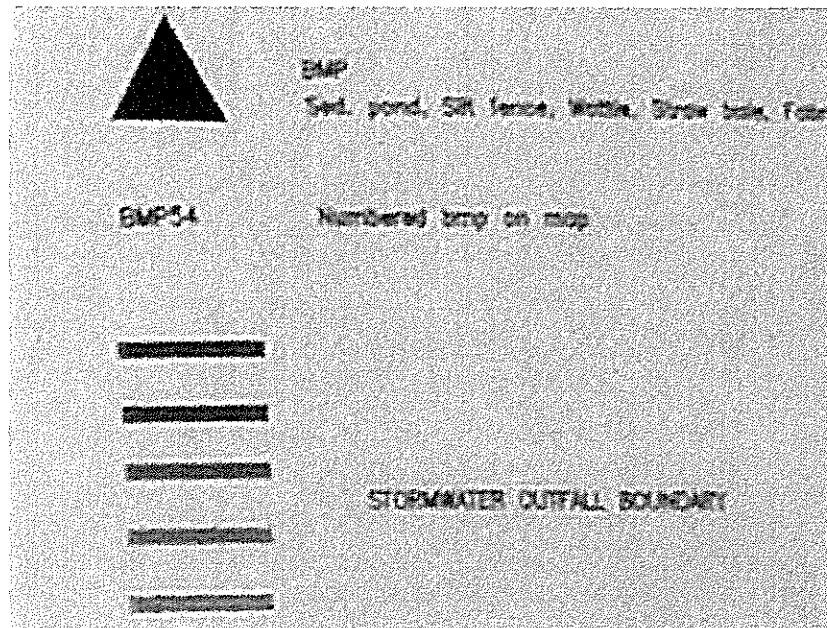
- The current map showing the location of best management practices (BMPs) used to control erosion and sedimentation are very general in nature; they use a standard symbol (a dark triangle) and a number to identify a general category of BMPs (see Photos 16-18). These maps are not detailed enough to show the exact location of the BMP placement, or (when appropriate) the number of BMPs within a particular category that have been installed. I recommended that Kinross create a more detailed map (or series of maps) that identify the specific location of BMPs as required by the MSGP.

This is a closer view of the BMP map. It provides general information about the BMPs that have been installed in a general area. It does not provide the type of detail that would identify the specific location for each BMP.

Photo No. 18 (P1020393 - Legend)  
 This is the map legend associated with the BMP map.

- The SWPPP (particularly the site map) must be updated routinely as conditions on the ground change. All updates can be recorded by hand.
- The SWPPP's site map needs greater detail to show specific locations where BMPs have been installed, added to, or removed.
- During the course of conducting routine facility inspections, when issues are noted that require some type of corrective action, you must note the specific date that corrective actions were implemented in order to verify compliance with the corrective action requirements in Part 4.3 of the 2015 MSGP.

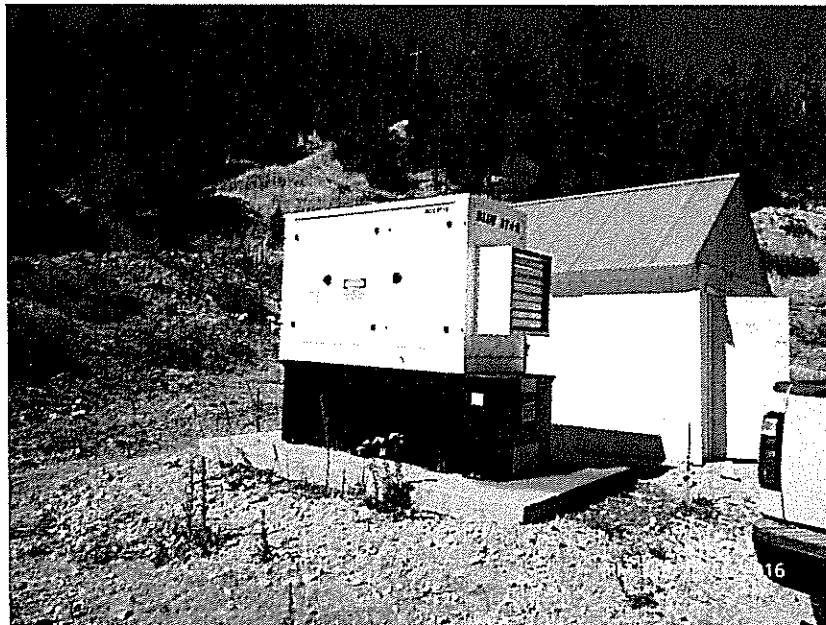
Photo No. 19 (P1020400)  
 Facing northwest – this is the pump house and the diesel-powered generator located midway down the Sullivan Gulch road. The pumps deliver wastewater from the WD-1 collectors to the WTB located on the opposite side of the mine site.

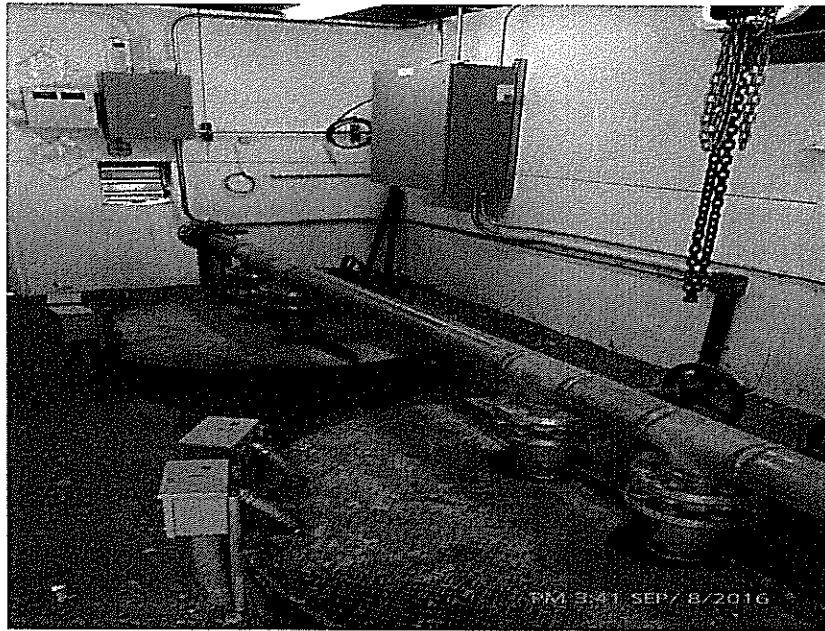
Photo No. 20 (P1020401)

These are the four pumps located within the Sullivan Gulch pumphouse. Typical flow into the well cans is reportedly 5-7 gpm. The maximum flow from WD-1 is reportedly 50 gpm.

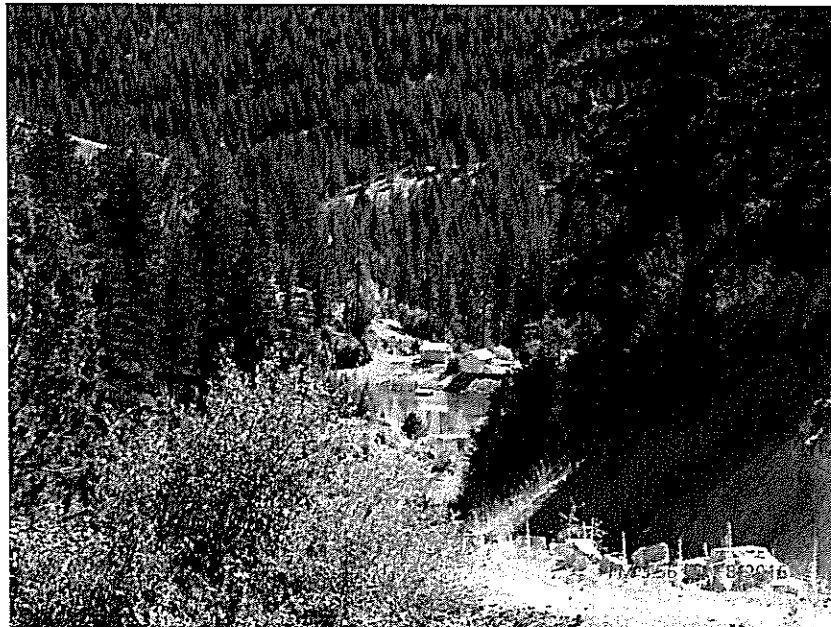
Photo No. 21 (P1020403)

Facing south – this photo, made from the Sullivan Gulch pumphouse parking area, provides a glimpse of the groundwater treatment system located at the end of the road.

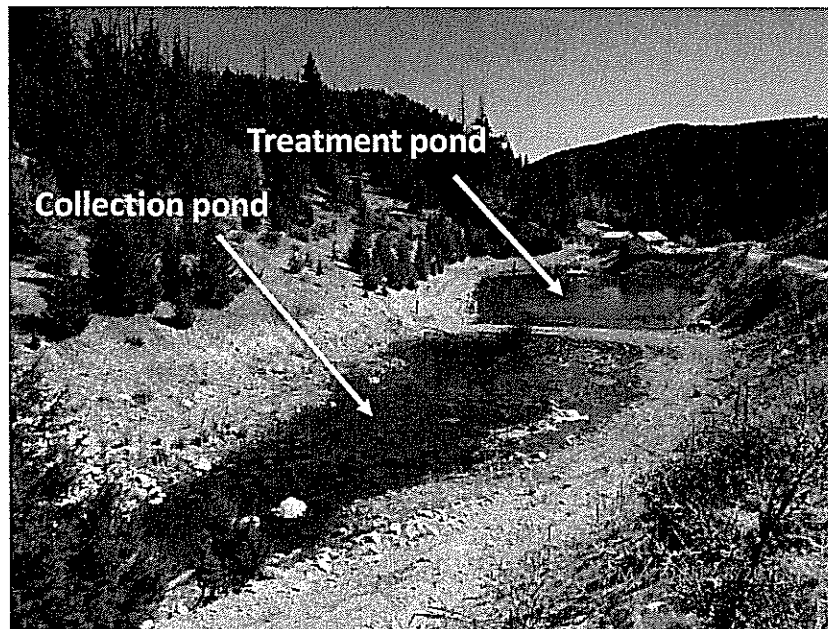
Photo No. 22 (P1020404)

1. Water from the springs accumulate in the collection pond (the clear pond on the left in Photo 22).
2. A float activated device pumps water from the collection pond into and through the groundwater treatment building.

4. The water from the collection pond, now containing the sodium hydroxide solution, is pumped from the groundwater treatment building to a manifold distribution system located at the upper end of the treatment pond (see Photo 22). The discharge of treated water through manifold system at the head of the treatment pond provides for greater mixing of the water within the pond.

Facing southeast – the first (clear) pond collects water from the spring. Water is pumped from this pond into and through the treatment building and back into the second (far) pond. From the second pond, the treated water is discharged to Louse Creek (temperature permitting) or to the Sullivan Gulch pumphouse.

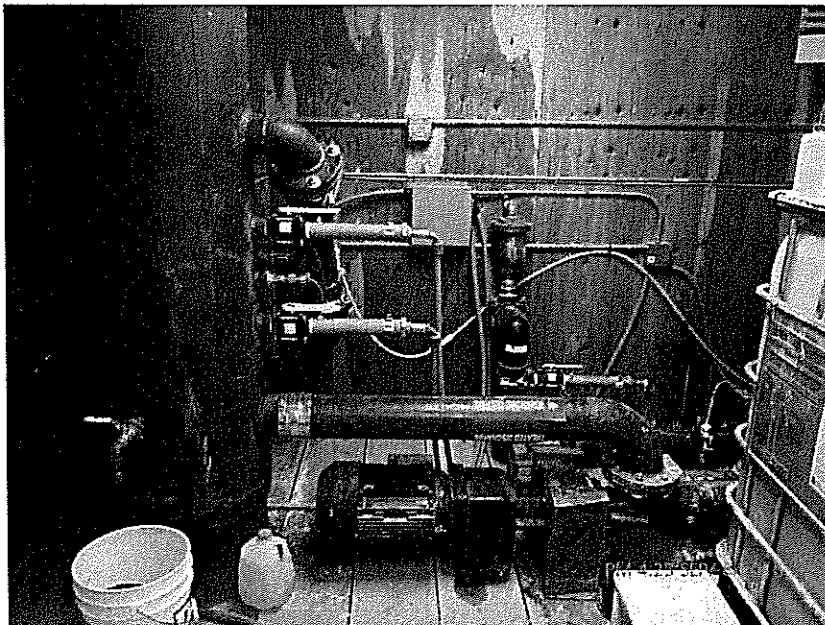
Photo No. 23 (P1020409)

3. Inside the treatment building, a 25% solution of sodium hydroxide is injected into the line transporting water from the collection pond (see Photo 23).

Inside the groundwater treatment building, a sodium hydroxide solution is used to adjust the pH of the water from the first pond before discharging it back to the second pond.

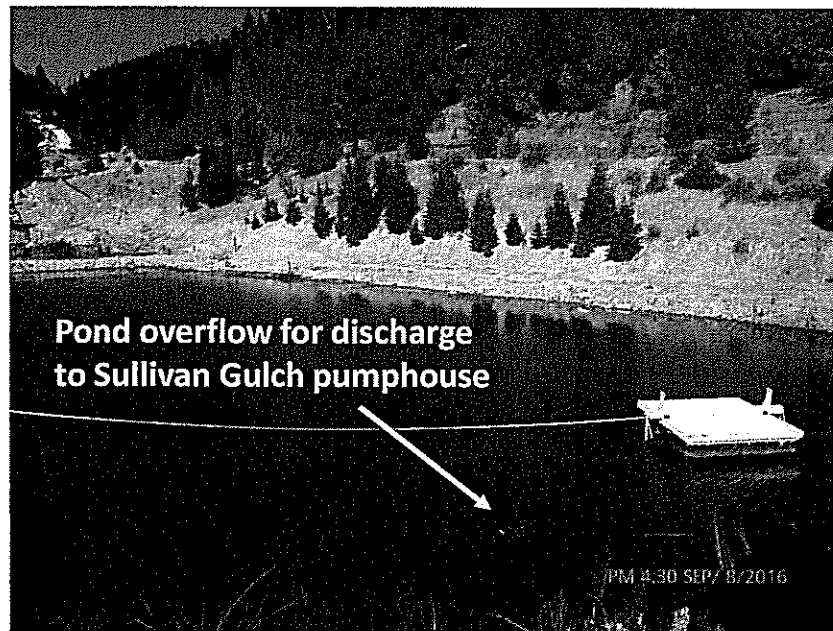
Photo No. 24 (P1020411)

5. A float-activated pump (mounted on a "barge") pumps water from the opposite end of the treatment pond back through the piping system in the treatment building where pH and temperature are continuously monitored in-line (see Photo 24).

7. If the flow of Louse Creek is too low or the temperature of the treated groundwater is too high, the barge-mounted pump in the treatment pond is automatically shut off. As the water level in the pond rises, it flows into a vertical decant pipe (see Photo 24) connected to an adjacent sump or "well can" (see Photo 26). From the well can, the water is pumped to the pump station located further up Sullivan Gulch where it is mixed with the wastewater from the WD-1 seeps and pumped across the site to the wastewater treatment building (WTB).

Facing northeast – a pump suspended from this barge pumps the treated water (temperature permitting) from the second pond back through the treatment building where pH and temperature are both monitored in-line. As long as the effluent is within permit limits, it can be discharged to Louse Creek.

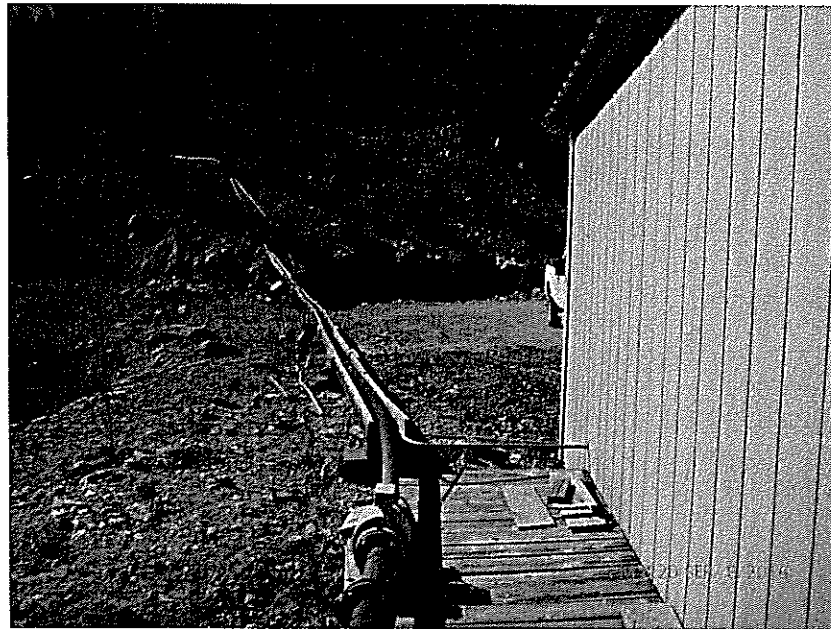
Photo No. 25 (P1020407)

Facing west – exiting the treatment building, this is the discharge line (with flow meter) to Louse Creek located at the base of Sullivan Gulch. .

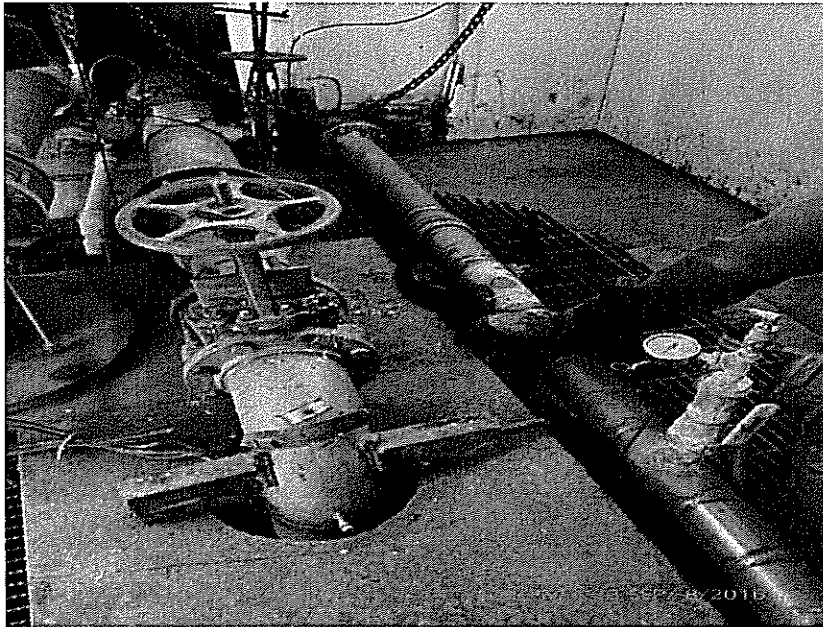
Photo No. 26(P1020410)

This pumphouse, located next to the groundwater treatment building, delivers treated groundwater to the Sullivan Gulch pumphouse when the water is too warm to discharge to Louse Creek.

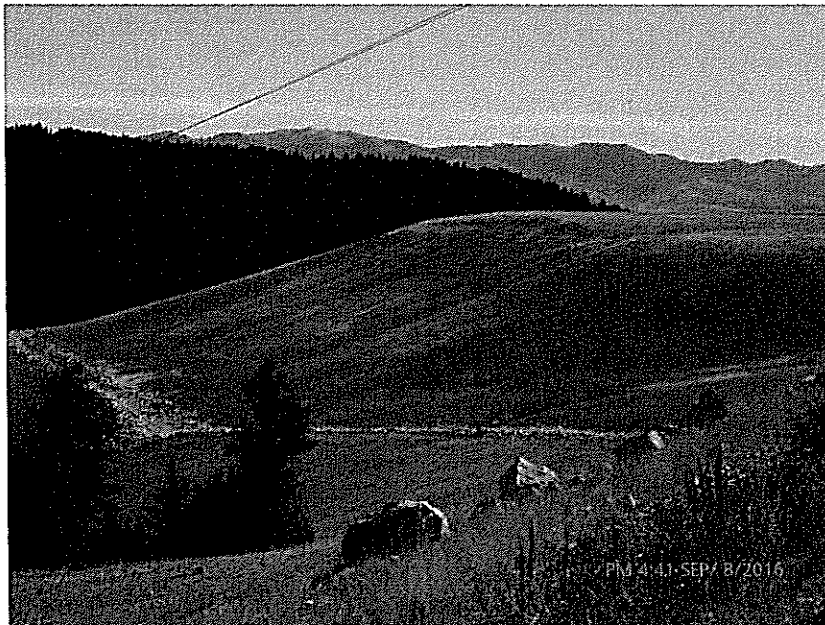
Photo No. 27 (P1020412)

Facing southwest – this is one of the armored trenches used to convey stormwater from the east side of WD-2 to Cabin Gulch

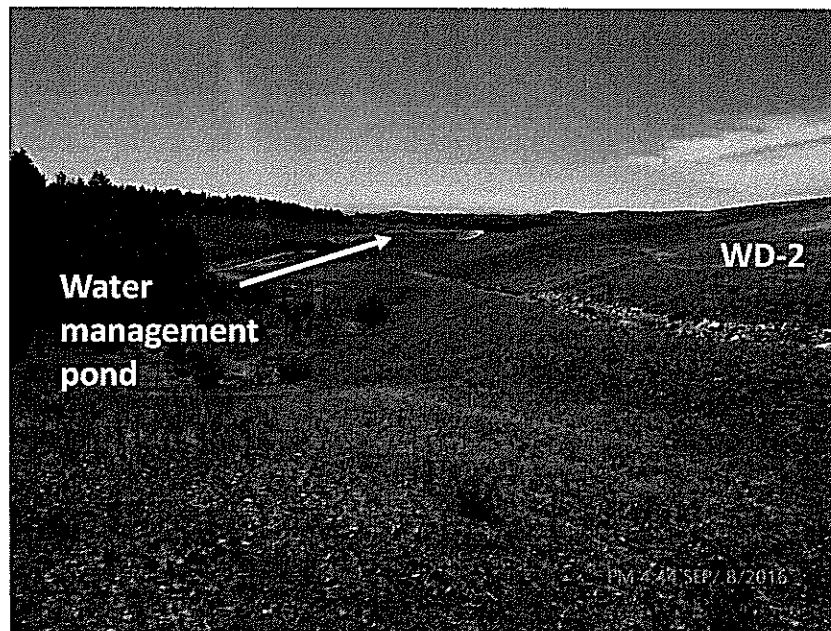
Photo No. 28 (P1020413)  
Facing southwest – the 350 acre-feet (> 114 million gallons) water management pond is located on the far side of WD-2.

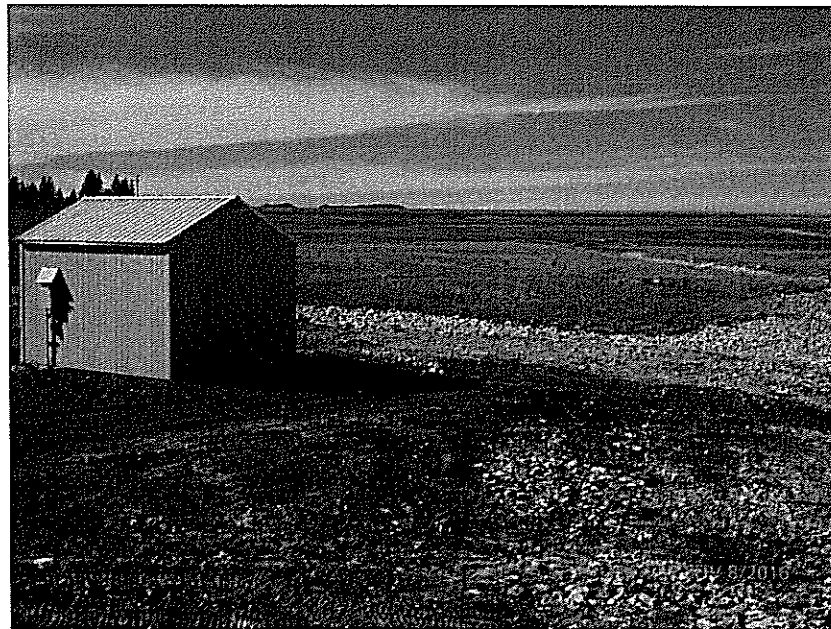
- Tailings pond collection system. An underdrain was installed within the tailings pond prior to capping as part of site remediation. All seepage collected in the underdrain reports to the *Tails Collection Pump House* (see Photos 29 and 31). From there, it is pumped to the WTB for treatment.

Photo No. 29 (P1020415)  
Facing northwest – armored trenches come together in an area near the base of the west side of WD-2 and the tailings pond. From this area, stormwater is conveyed to the Cabin Gulch trench. The *Tails Collection Pump House* collects seepage from the tailings pond and delivers it to the WTB.

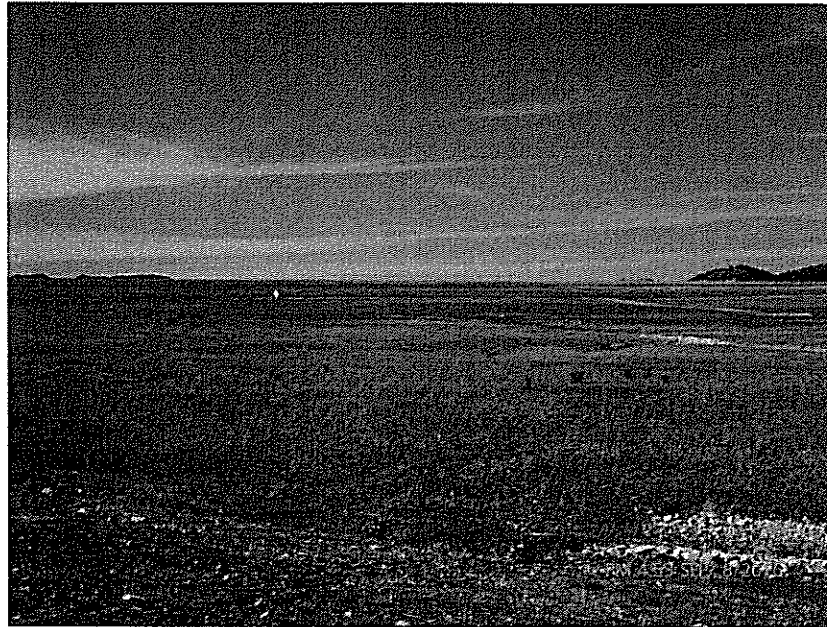
Photo No. 30 (P1020416)  
Facing northwest – cattle graze on the vegetated surface of the capped tailings pond.

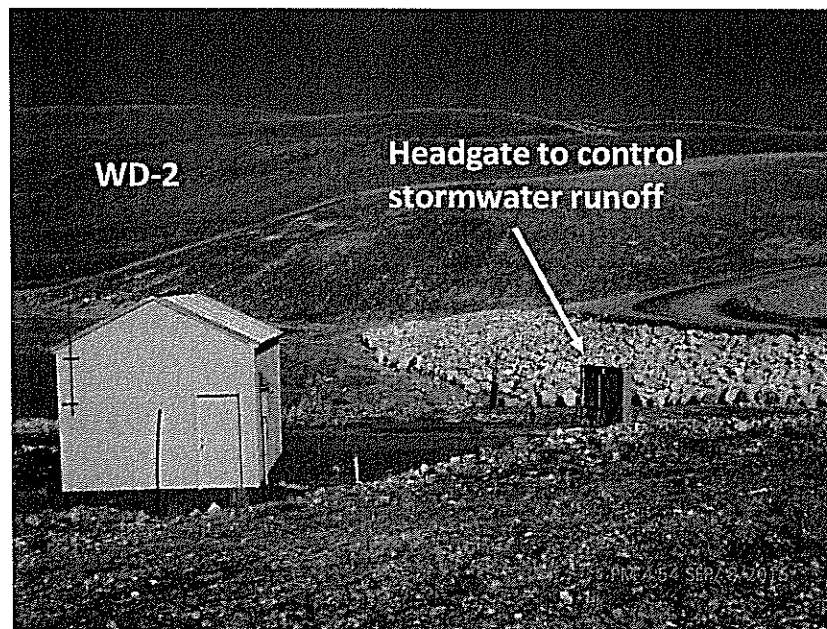
Photo No. 31 (P1020419)  
Facing northeast – stormwater runoff from the west side of WD-2 and the capped tailings pond flows down to this headgate. The *Tails Collection Pump House* delivers seepage from the tailings pond to the WTB.

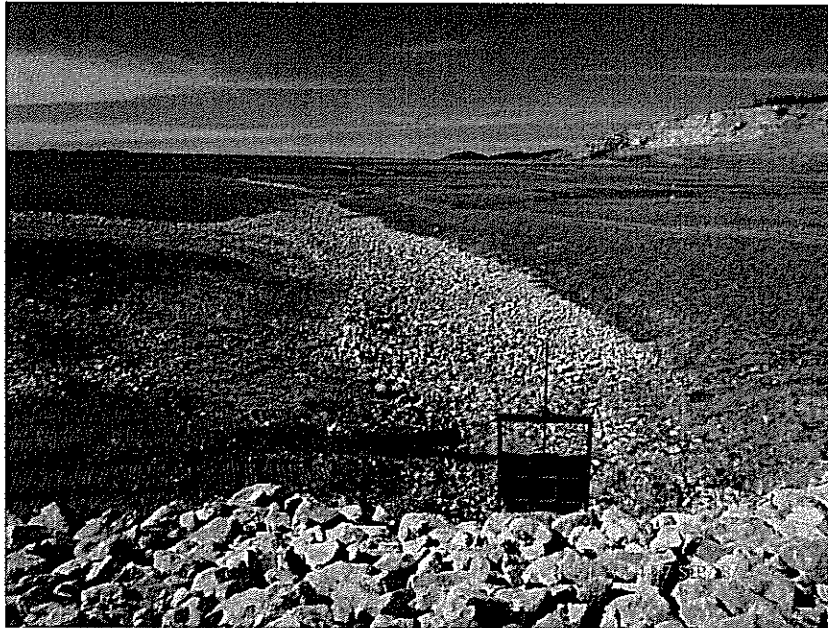
Photo No. 32 (P1020421)

Facing north – this headgate, installed on the upstream side of a culvert under the main road around the site, can backup stormwater runoff to prevent it from washing out the culvert at very high flow.

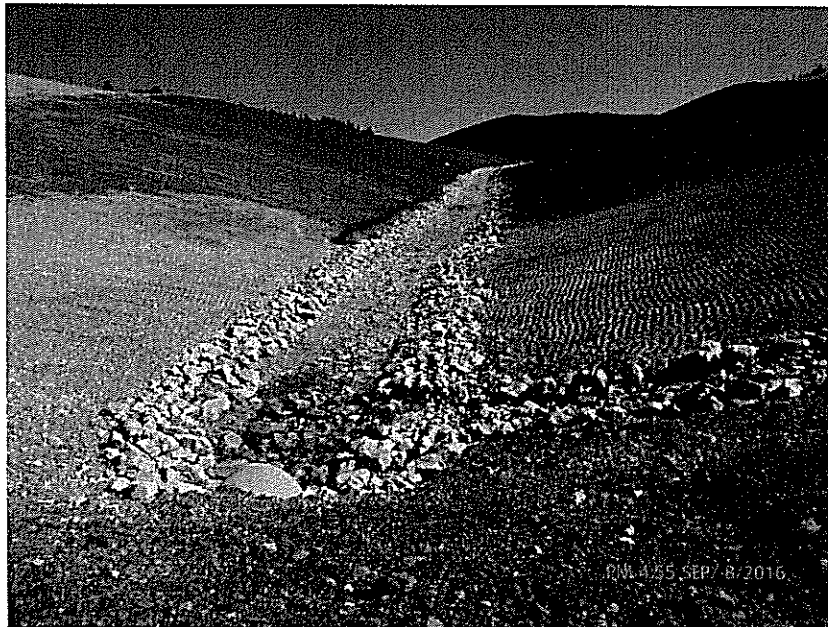
Photo No. 33 (P1020420)

Facing south – this is the downstream side of the culvert noted in the previous photo. The armored channel conveys stormwater down Cabin Gulch to Louse Creek.

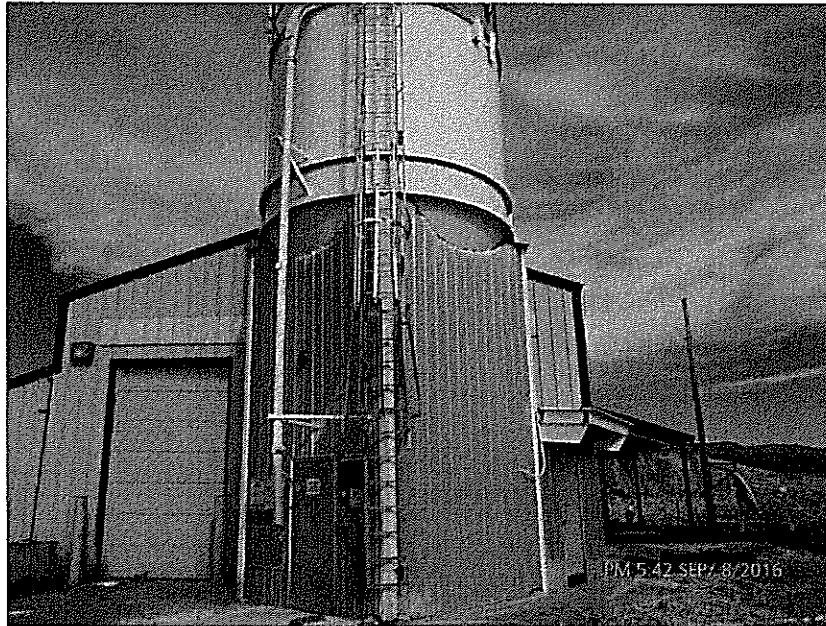
Photo No. 34 (P1020437)

Facing northeast – the wastewater treatment building (WTB), located near the SW corner of the former tailings pond, uses a lime slurry to adjust the pH of the mine seepage collected from various locations around the site.

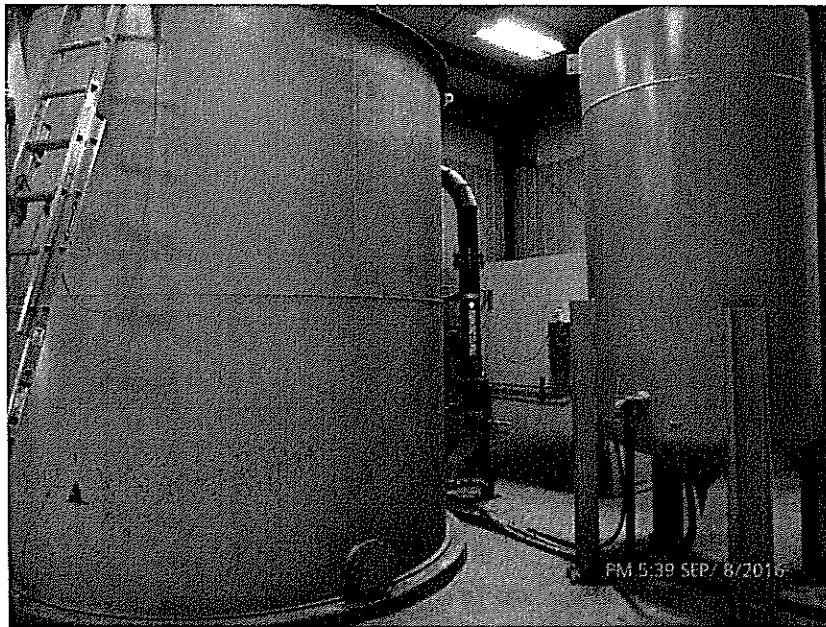
Photo No. 35 (P1020436)

The mine wastewater is treated in the larger tank. A similar tank is available if needed but has not been used in many years.

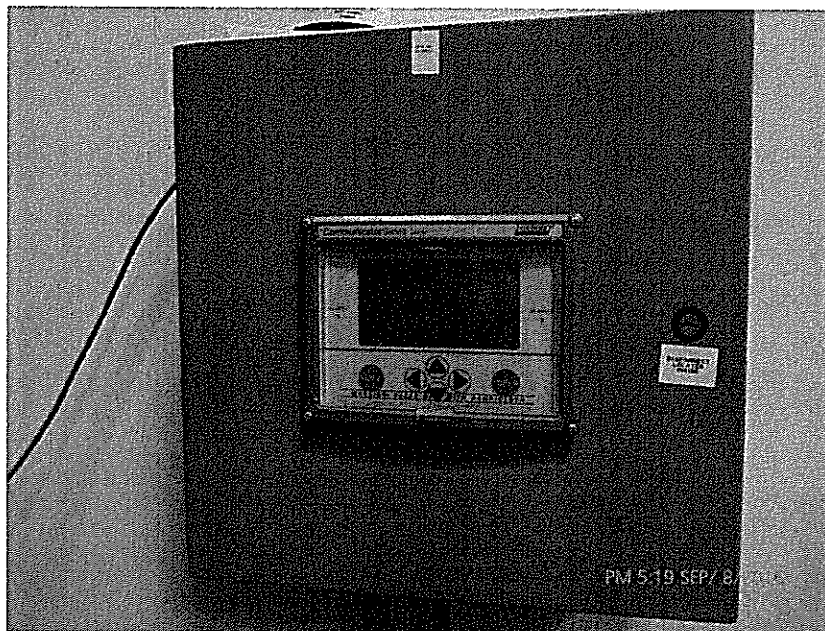
Photo No. 36 (P1020433)

The pH of the treated wastewater is continuously monitored prior to discharge to the adjacent settling pond.

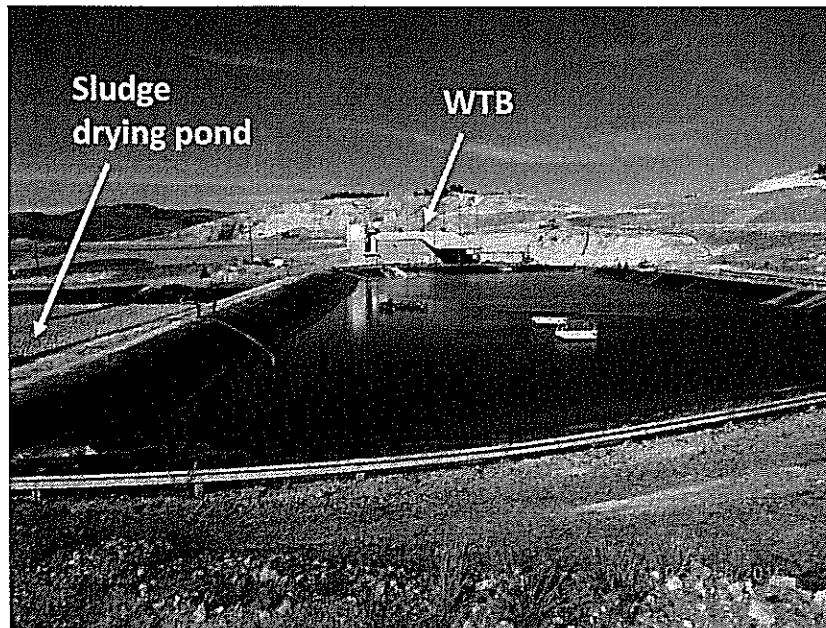
Photo No. 38 (P1020424)

Facing north – the treated wastewater from the WTB is discharged to this settling pond. Water is pumped from this pond to the WMP (located to the right of the settling pond – not visible in this photo).  
The sludge from the bottom of the pond is transferred to the new drying pond on the left.

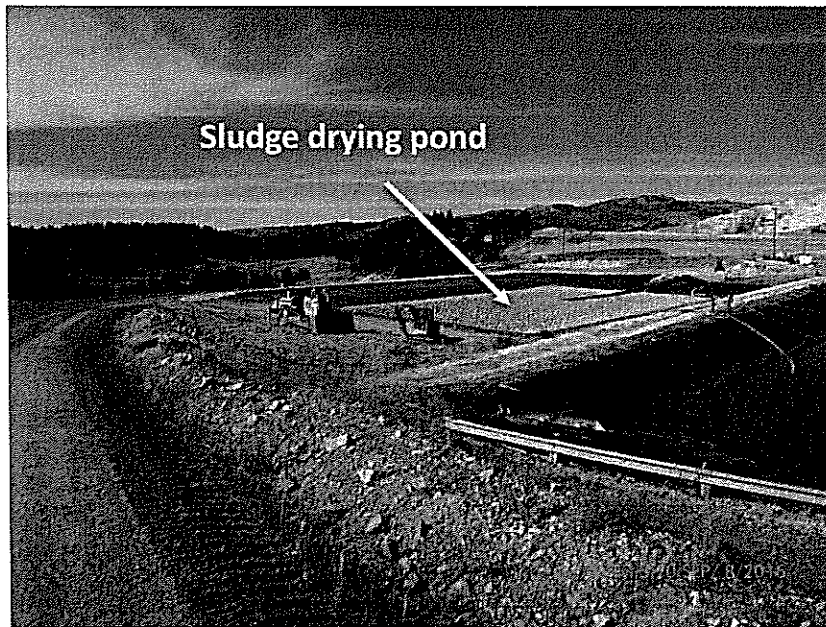
Photo No. 39 (P1020426)

Facing northwest – a new sludge drying pond was installed since the time of the July 29, 2014 inspection.

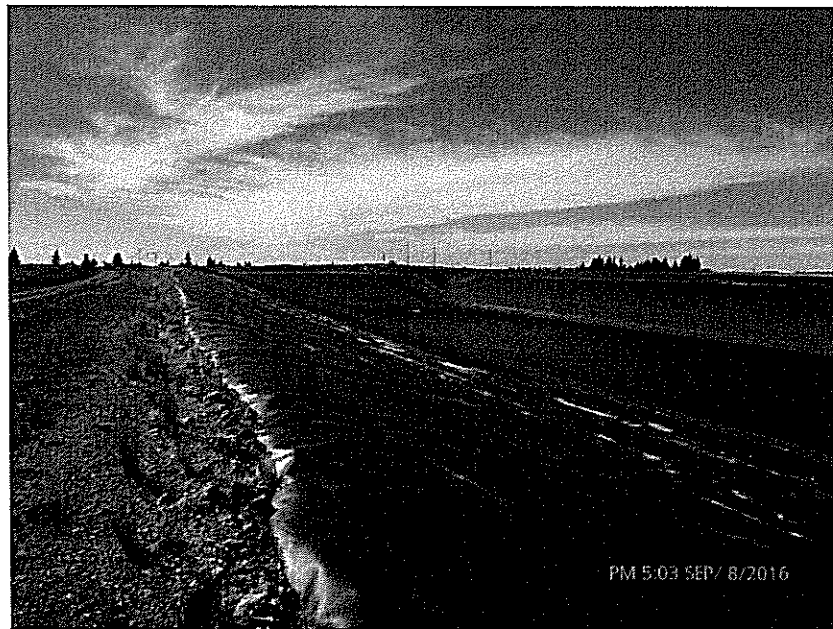
Photo No. 41 (P1020422)

Facing west – armored stormwater conveyance near sump collecting mine seepage from WD #1

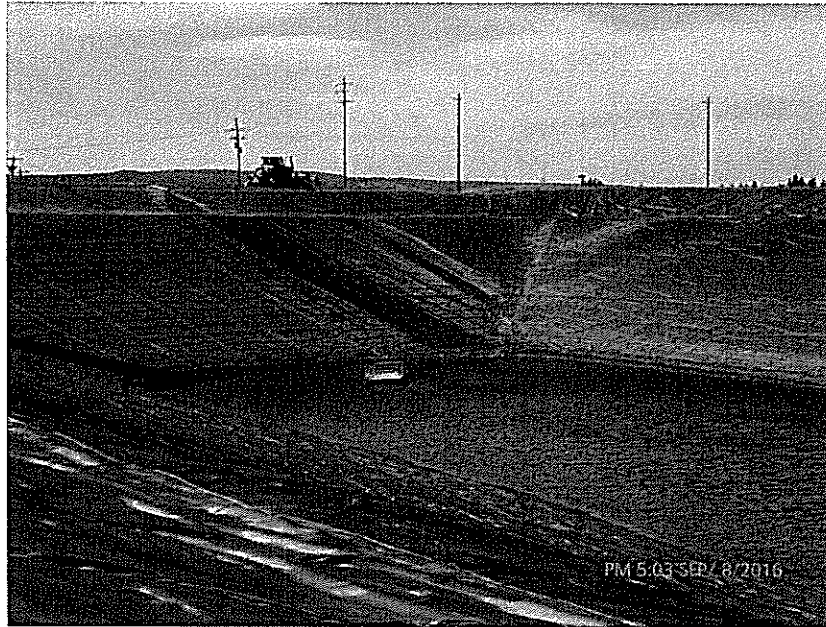
Photo No. 42 (P1020423)  
Facing west – armored stormwater conveyance on the east side  
of WD #1 near start of road down Sullivan Gulch.
